TITLE: PRELIMINARY GUIDELINES FOR MAINTENANCE OF
POLYURETHANE FOAM (PUF) ROOFING SYSTEMS

AUTHOR: R. L. Alumbaugh, S. R. Conklin, and D. A. Zarate

DATE: March 1984

NAVAL CIVIL ENGINEERING LABORATORY
PORT HUENEME, CALIFORNIA 93043

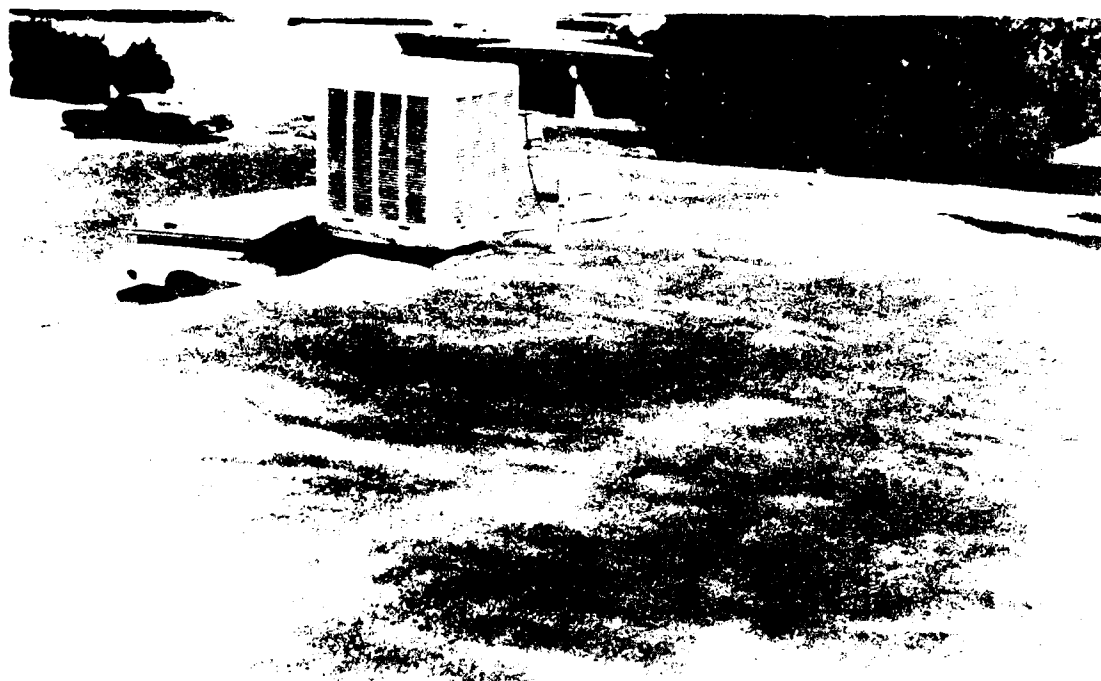
Figure 6. Overview of refurbished polyurethane foam roof with urethane coating and mineral roofing granules (NAS Lemoore).

After the sanding was completed, all loose foam and dust were blown from the roof with an air hose, and the existing foam was given a tiecoat of hydrocarbon primer used principally to assure good bonding between old and new foam. Following the priming, an additional 1-1/2 inches of new foam (3-lb/ft³ density) was applied (Figure 5). Then a catalyzed urethane was applied in three coats, with each coat applied at the rate of 1 gal/100 ft². Mineral roofing granules were broadcast into the wet topcoat at the rate of 50 lb/100 ft². The dry film thickness of the coating was approximately 30 mils. An overview of a finished roof is shown in Figure 6.

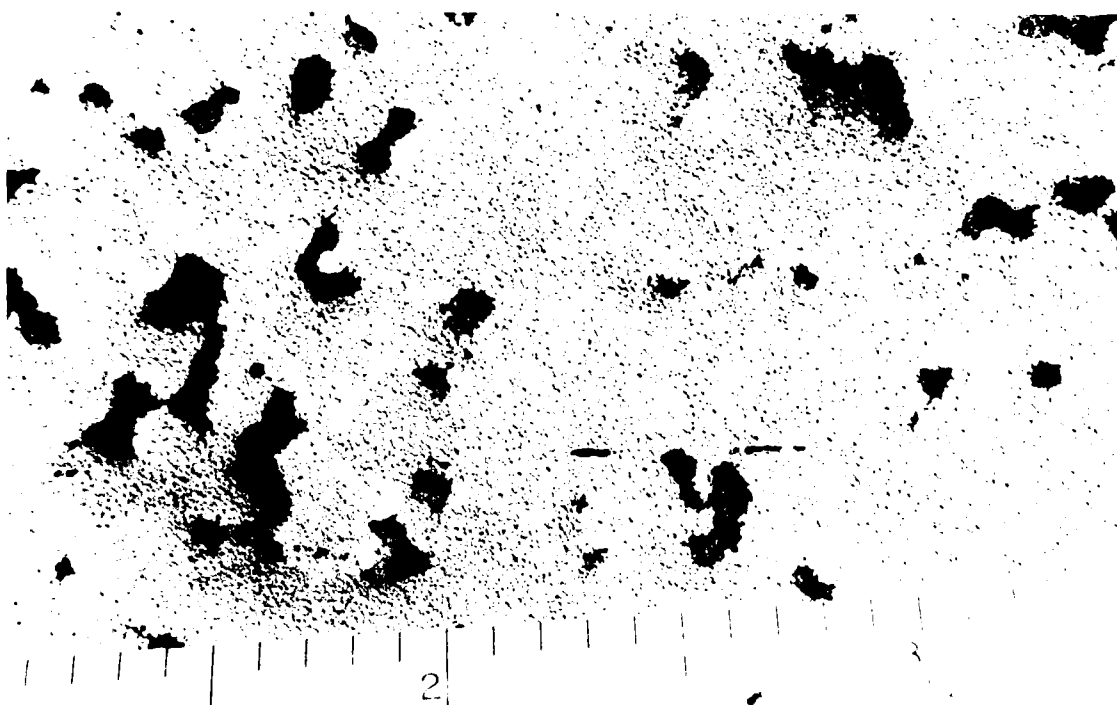
Figure 8. Weathered moisture-cured urethane-coated foam panel after brooming (system 1F-2).

(a) Full panel view.

(b) Photomacrograph (~ 4 in.²).
